# Derailment of Cairns Tilt Train VCQ5

North of Berajondo, Queensland  
15 November 2004

RAIL SAFETY INVESTIGATION  
QT1472

**Derailment of Cairns Tilt Train VCQ5**  
**North of Berajondo, Queensland**  
**15 November 2004**

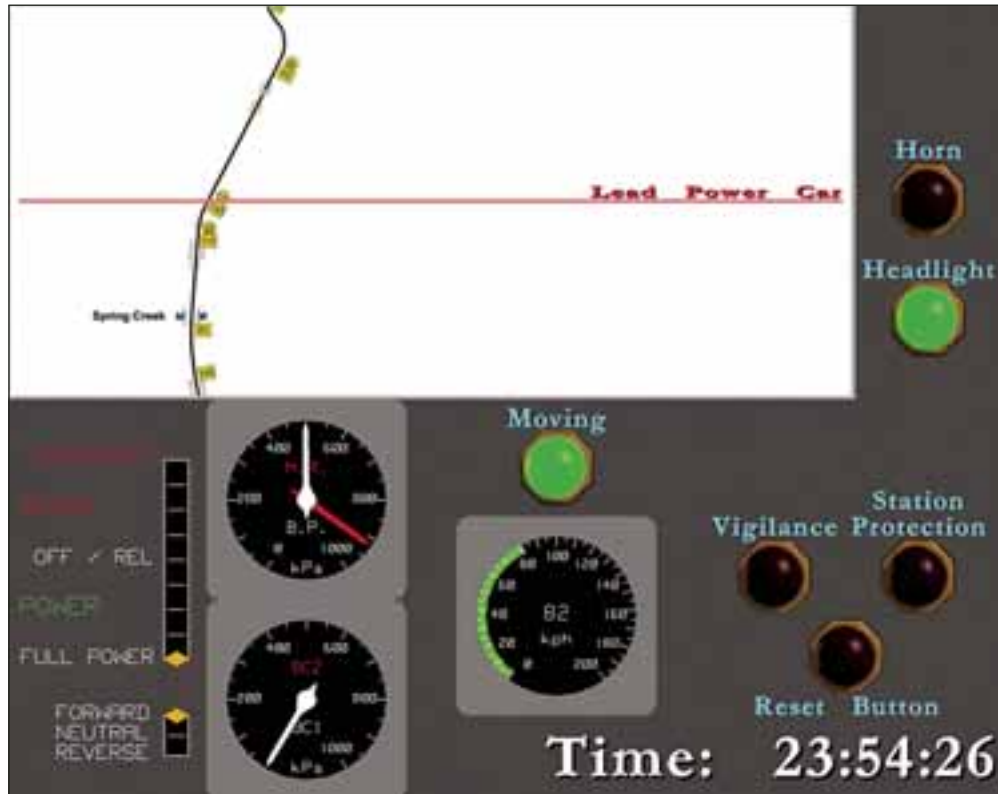
FIGURE 3: Train approx at 417.783 km, location of 150 km/h 'Speed Board'. Train accelerates from 82 km/h under full power

At 2352:41 (Fig. 5) the power car passed over the Berajondo 'up' station protection magnet, located at 415.470 km at a speed of 72 km/h, about 3 km/h below the maximum permitted speed. The driver increased power until reaching a speed of just over 81 km/h at 2353:13. The train was maintained close to this speed through 800m of track designated as 100 km/h and then through a 900m section of track from 416.480 km to 417.380 km designated as 80 km/h. At 2354:26 (Fig. 3) the driver placed the throttle at 100 per cent power and the train accelerated and reached a speed of 105 km/h, at 2354:52 (Fig. 4) the throttle was placed at about 60 per cent power.
